Inspection Report

1234 Avenue D Torrance, CA 90505

Prepared Exclusively For:
John Smith

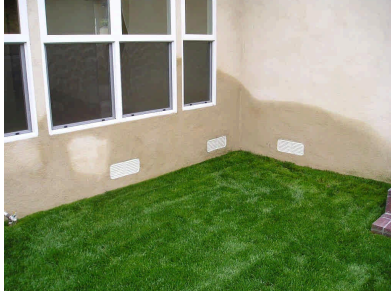
1. [CR] Sprinkler heads spray the house. This can promote damage to the siding, trim or structure. We suggest the sprinkler heads be adjusted or repaired to ensure that they do not spray the building.

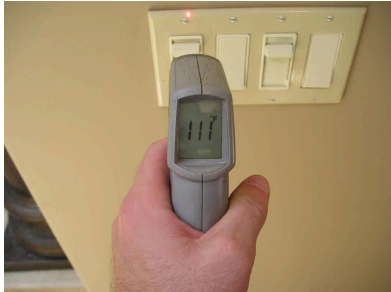
4. [CR] The cover plates for one or more receptacles in living room are damaged or missing. This can expose live wires which can be a shock hazard. We suggest for or electrical safety, any missing cover plate should be replaced.
5. [CR] A dimmer light switch in family room was hot at the time of this inspection. This suggests a defective device, or incompatibility between the ratings of the bulb(s) and the dimmer. This condition is a fire risk. We suggest a qualified electrician could replace the switch.

[CR] The cover plates for one or more receptacles in living room are damaged or missing. This can expose live wires which can be a shock hazard. We suggest for or electrical safety, any missing cover plate should be replaced.

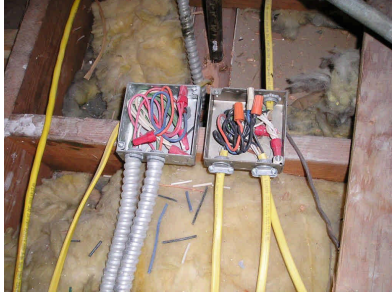
6. [CR] In the attic there are open junction boxes. Lack of covers on junction boxes is a shock or fire hazard. We DID NOT necessarily list all locations. We suggest a qualified electrician should check the system and install a proper cover on all junction boxes.

[CR] In the attic there are open junction boxes. Lack of covers on junction boxes is a shock or fire hazard. We DID NOT necessarily list all locations. We suggest a qualified electrician should check the system and install a proper cover on all junction boxes.

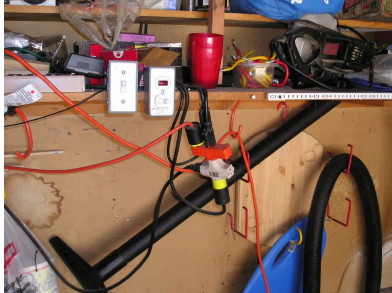
7. [CR] In the garage extension cords are being used as permanent wiring. Extension cords are not appropriate for use in permanent installations, are easy to overload, and are easily damaged, which can create a shock or fire hazard. We suggest removal of all permanently installed extension cords and replacement with appropriate, permanent wiring is recommended. A licensed electrician should install all permanent wiring.

[CR] In the garage extension cords are being used as permanent wiring. Extension cords are not appropriate for use in permanent installations, are easy to overload, and are easily damaged, which can create a shock or fire hazard. We suggest removal of all permanently installed extension cords and replacement with appropriate, permanent wiring is recommended. A licensed electrician should install all permanent wiring.

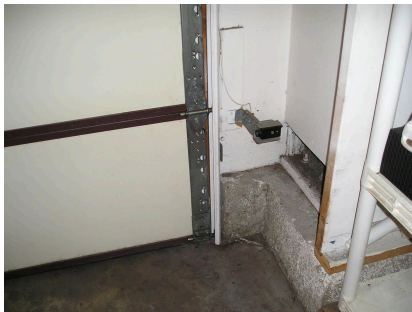
8. [SC] [CR] The optical sensor or track beam installed on the garage door opener (which activates the reversing eye system) is installed at the incorrect height. This could allow small children or animals to move under the beam without activating the safety feature. This is a safety concern. We suggest the optical sensor or track beam should be installed six inches above the floor of the garage or in accordance with the manufacturer's specifications by a qualified garage door technician.
