# Inspection Report

1234 Main Street  
Torrance, California 90505

Monday, July 4, 2022

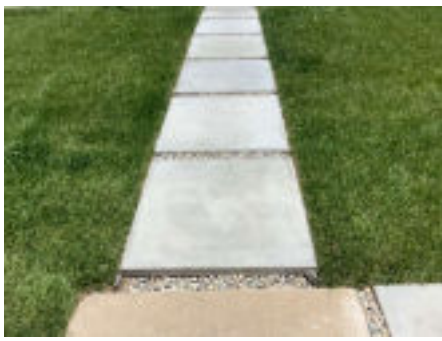
**SC** **s-21:** The gap between the walkway sections creates an uneven and/or unstable surface. This condition poses a trip hazard, especially for someone wearing heels. We recommend correcting the condition(s) noted for safety reasons.

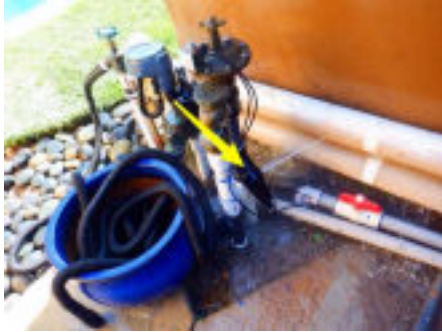
- CR** **s-25:** Testing of the landscape irrigation system is beyond the scope of this inspection. However, one or more of the sprinkler components leaks at the left rear of the building. We suggest that all leaking, malfunctioning or damaged sprinkler components should be repaired or replaced.

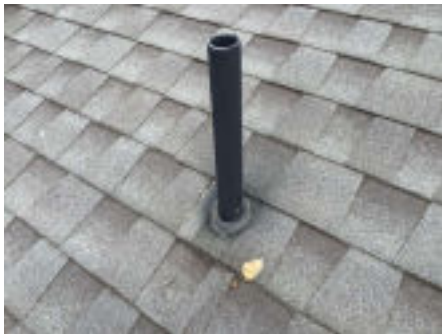
Missing

- CR** **s-44:** A jack/vent flashing on the left side of the roof is missing. This can allow leaks. We suggest a qualified roofer should replace all missing, improperly installed, damaged or deteriorated flashings.
