CARROLL
PROPERTY INSPECTIONS

Inspection Report

1234 Main Street
Torrance, California 90505

Monday, July 4, 2022

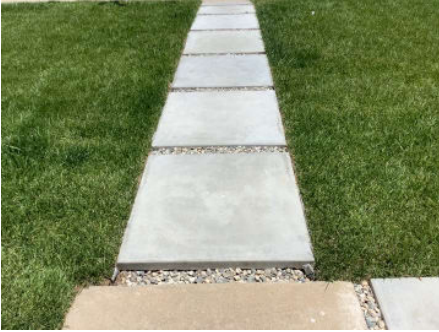
SC s-21: The gap between the walkway sections creates an uneven and/or unstable surface. This condition poses a trip hazard, especially for someone wearing heels. We recommend correcting the condition(s) noted for safety reasons.

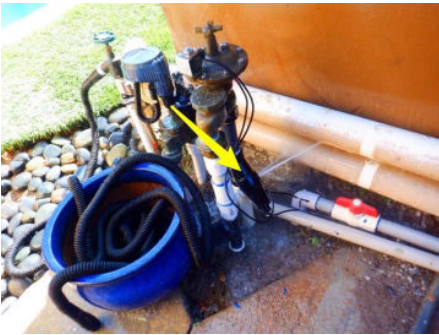
CR s-25: Testing of the landscape irrigation system is beyond the scope of this inspection. However, one or more of the sprinkler components leaks at the left rear of the building. We suggest that all leaking, malfunctioning or damaged sprinkler components should be repaired or replaced.

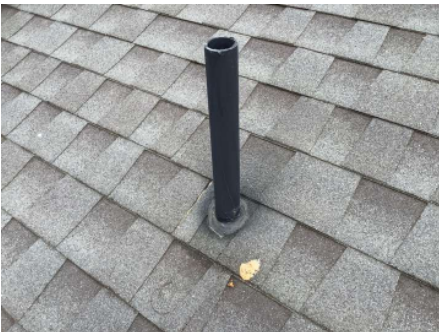
Missing

CR s-44: A jack/vent flashing on the left side of the roof is missing. This can allow leaks. We suggest a qualified roofer should replace all missing, improperly installed, damaged or deteriorated flashings.

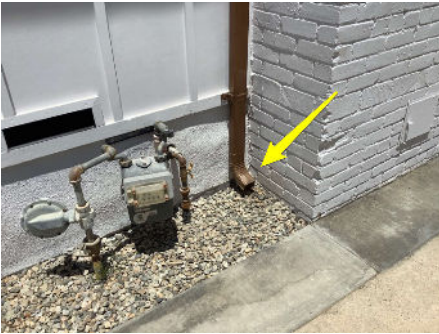
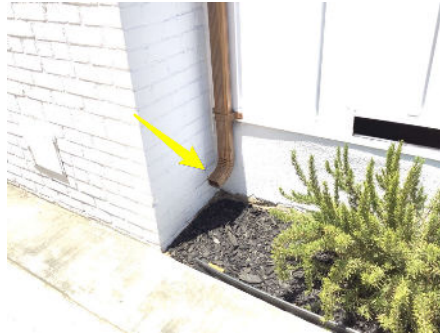
CR s-46: Downspouts empty water into confined areas on several sides of the building. This can promote flooding or ponding. We suggest the downspouts should be rerouted to a better location or connected to subsurface drains.

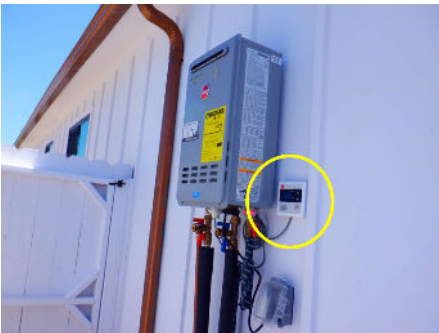
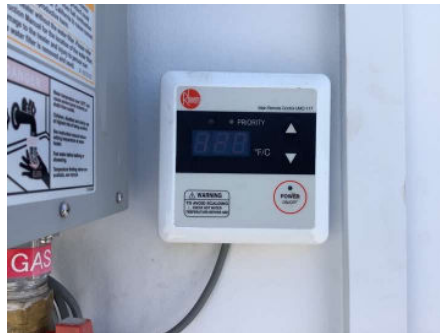
CR s-83: The remote control for the water heater is installed on the exterior. The control is subject to damage from exterior elements and this is contrary to manufacturers installations requirements. We suggest that a qualified plumber should install the remote an acceptable interior location.

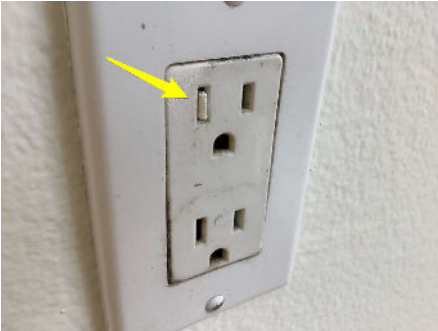
Dining room

CR s-103: In the area(s) listed below receptacle(s) have an obstruction in one or more of the plug openings. We suggest the receptacle(s) should be repaired/replaced. A qualified technician should do the work.

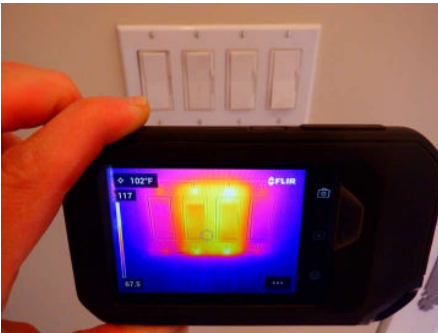
Living room

CR s-105: In the area(s) listed below one or more dimmer light switches were hot at the time of this inspection. This suggests a defective device, or incompatibility between the ratings of the bulb(s) and the dimmer. This condition is a fire risk. We suggest a qualified electrician could replace the switch.

117°

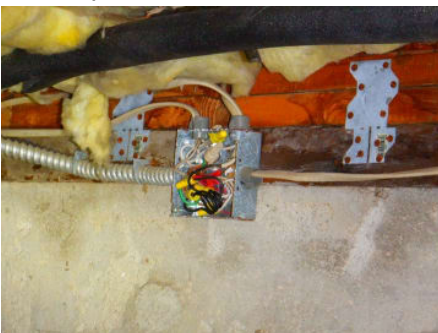
Crawlspace

CR s-107: In the area(s) listed below there is open junction box(es). Lack of covers on junction boxes is a shock or fire hazard. We DID NOT necessarily list all locations. We suggest a qualified electrician should check the system and install a proper cover on all junction boxes.

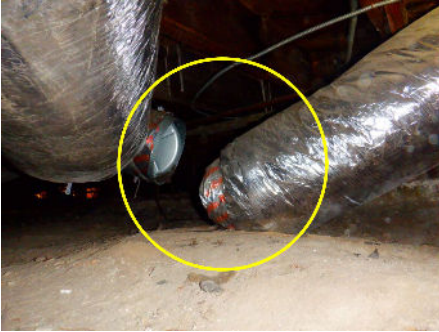
CR s-117: Joint(s) in the ductwork serving family room have come apart. This allows a significant leak of conditioned air. We suggest a qualified heating technician should repair the all disconnected ducts.

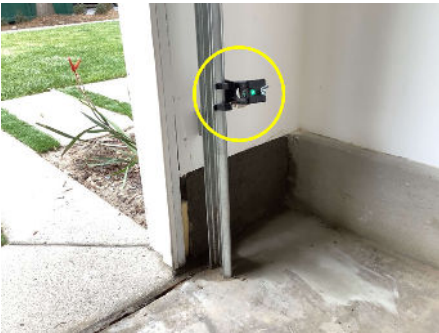
CR s-135: The optical sensor or track beam installed on the garage door opener (which activates the reversing eye system) is installed at the incorrect height, more than 6 inches above the floor. This could allow small children or animals to move under the beam without activating the safety feature. This is a safety concern. We suggest the optical sensor or track beam should be installed six inches above the floor of the garage or in accordance with the manufacturer's specifications by a qualified garage door technician.

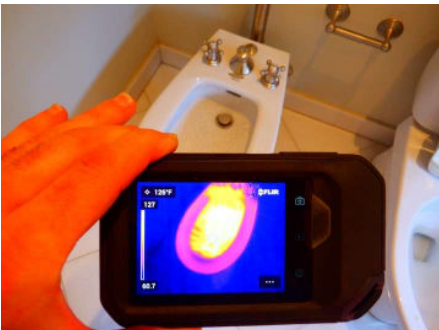
SC s-168: The temperature for the bidet hot water is set too high. Excessively-high water temperature above 110 degrees F. can cause scalding injury. We suggest a qualified plumber should make corrections as necessary.

127°

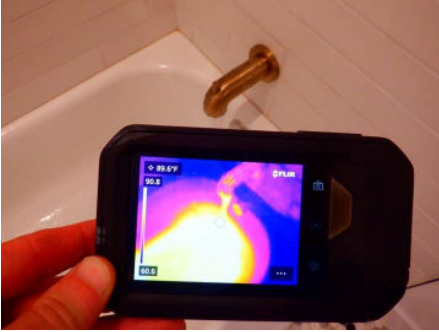
CR s-172: The temperature of the tub/shower water does not get very hot on the high setting. We suggest a qualified plumber should evaluate the temperature control mixing valve and make repairs as necessary.

90°

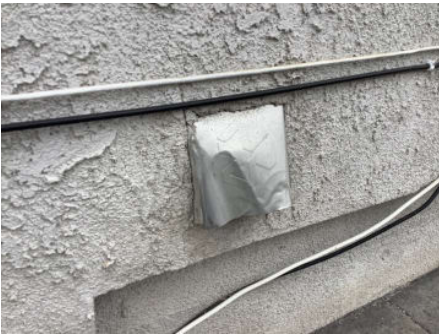
CR s-177: The dryer exterior vent cap is bent or damaged and can clog with lint, dirt or debris. This can be a fire hazard, and reduces dryer efficiency. We suggest the vent cap should be replaced.

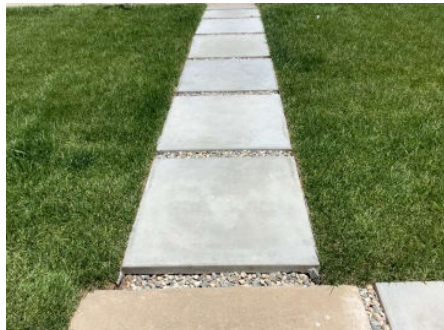
SC 21: The gap between the walkway sections creates an uneven and/or unstable surface. This condition poses a trip hazard, especially for someone wearing heels. We recommend correcting the condition(s) noted for safety reasons.

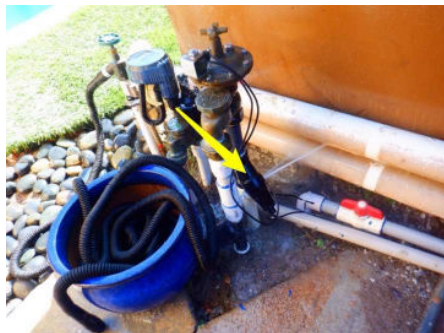
CR 25: Testing of the landscape irrigation system is beyond the scope of this inspection. However, one or more of the sprinkler components leaks at the left rear of the building. We suggest that all leaking, malfunctioning or damaged sprinkler components should be repaired or replaced.

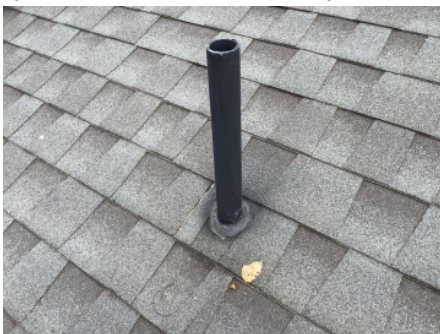
Missing

CR 44: A jack/vent flashing on the left side of the roof is missing. This can allow leaks. We suggest a qualified roofer should replace all missing, improperly installed, damaged or deteriorated flashings.

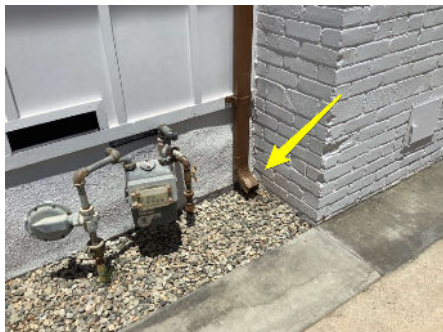
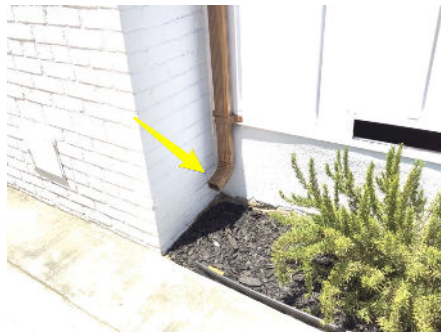
CR 46: Downspouts empty water into confined areas on several sides of the building. This can promote flooding or ponding. We suggest the downspouts should be rerouted to a better location or connected to subsurface drains.

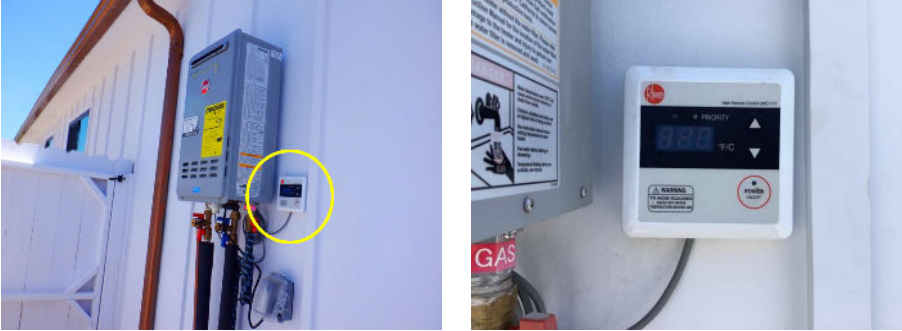
CR 83: The remote control for the water heater is installed on the exterior. The control is subject to damage from exterior elements and this is contrary to manufacturers installations requirements. We suggest that a qualified plumber should install the remote an acceptable interior location.

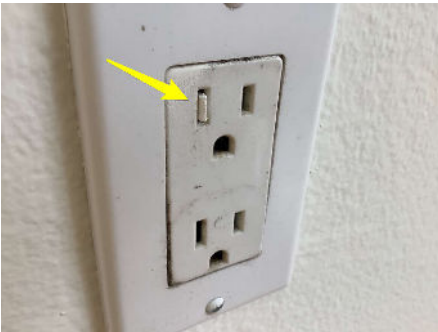
CR 103: In the area(s) listed below receptacle(s) have an obstruction in one or more of the plug openings. We suggest the receptacle(s) should be repaired/replaced. A qualified technician should do the work.
Dining room

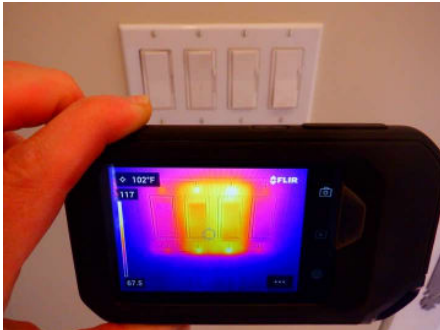
Living room

CR 105: In the area(s) listed below one or more dimmer light switches were hot at the time of this inspection. This suggests a defective device, or incompatibility between the ratings of the bulb(s) and the dimmer. This condition is a fire risk. We suggest a qualified electrician could replace the switch.

117°

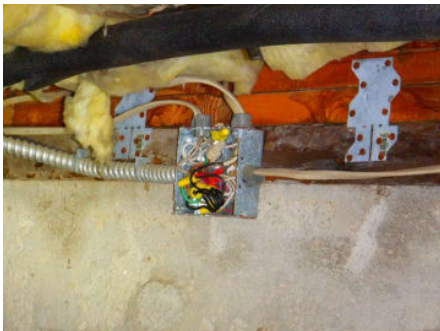
Crawlspace

CR 107: In the area(s) listed below there is open junction box(es). Lack of covers on junction boxes is a shock or fire hazard. We DID NOT necessarily list all locations. We suggest a qualified electrician should check the system and install a proper cover on all junction boxes.

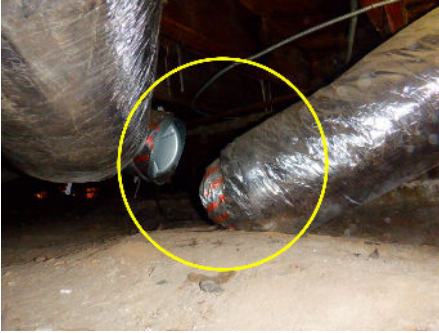
CR 117: Joint(s) in the ductwork serving family room have come apart. This allows a significant leak of conditioned air. We suggest a qualified heating technician should repair the all disconnected ducts.

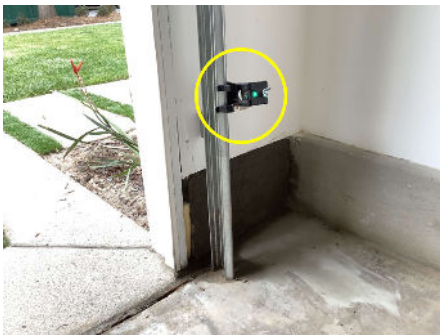
CR 135: The optical sensor or track beam installed on the garage door opener (which activates the reversing eye system) is installed at the incorrect height, more than 6 inches above the floor. This could allow small children or animals to move under the beam without activating the safety feature. This is a safety concern. We suggest the optical sensor or track beam should be installed six inches above the floor of the garage or in accordance with the manufacturer's specifications by a qualified garage door technician.

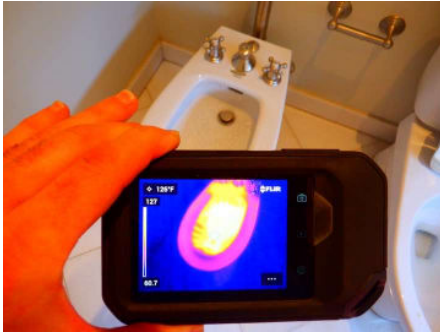
SC 168: The temperature for the bidet hot water is set too high. Excessively-high water temperature above 110 degrees F. can cause scalding injury. We suggest a qualified plumber should make corrections as necessary.

127°

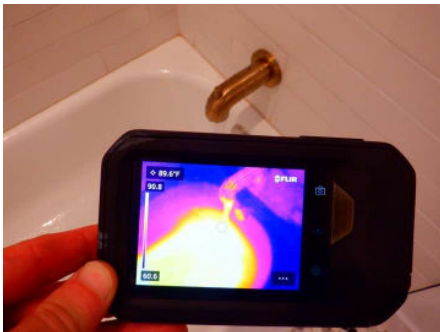
CR 172: The temperature of the tub/shower water does not get very hot on the high setting. We suggest a qualified plumber should evaluate the temperature control mixing valve and make repairs as necessary.

90°

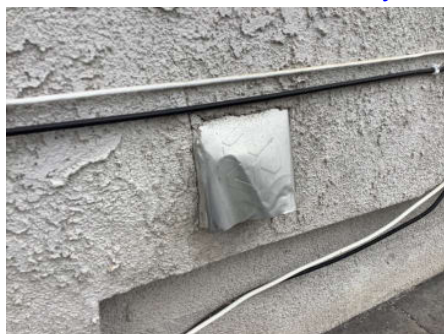
CR 177: The dryer exterior vent cap is bent or damaged and can clog with lint, dirt or debris. This can be a fire hazard, and reduces dryer efficiency. We suggest the vent cap should be replaced.
